Jul 1st, 2025

Home Inspection Report

Neal Frechette / Rising Tide Home Inspection

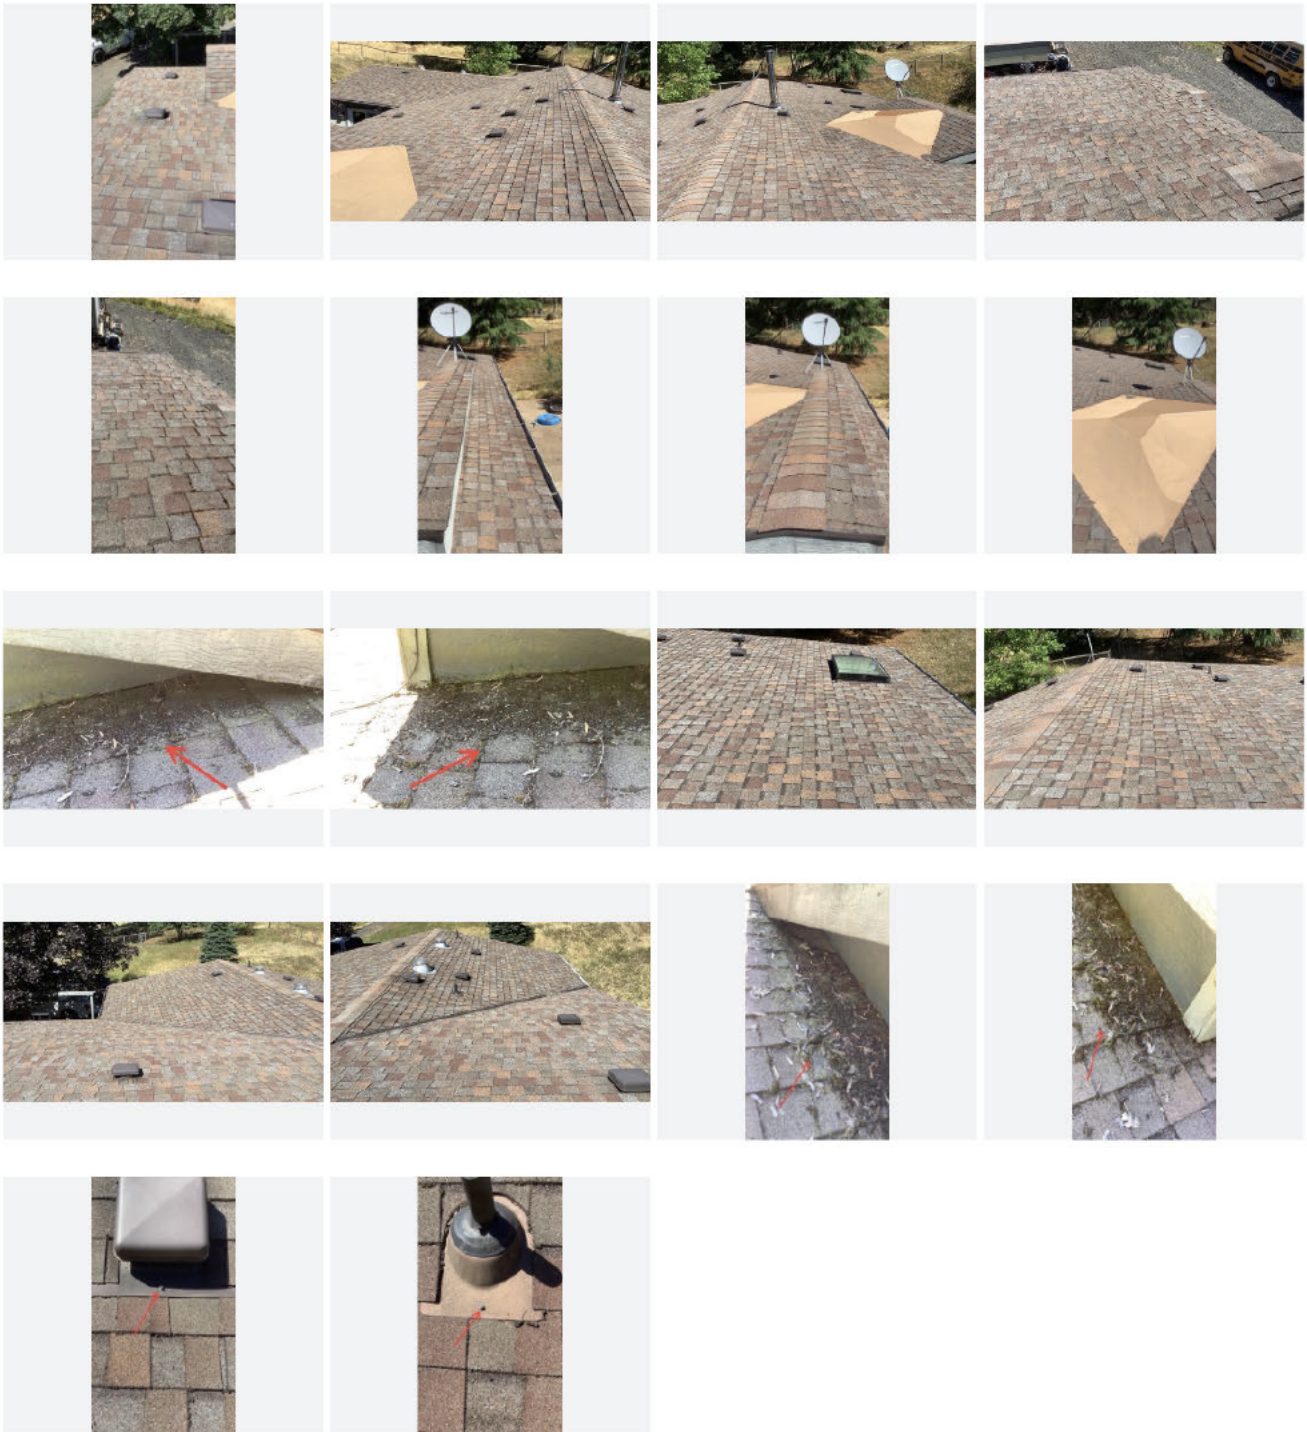
Marginal

Overall the roof was in good condition with only minor granule loss as expected as a roof ages and no acute damage was observed. However, there was dried moss and some debris on the roof, recommend the roof be

cleaned of debris and moss. Also, recommend sealing all screw/nail heads as seen in the last two photos with a waterproof sealant.

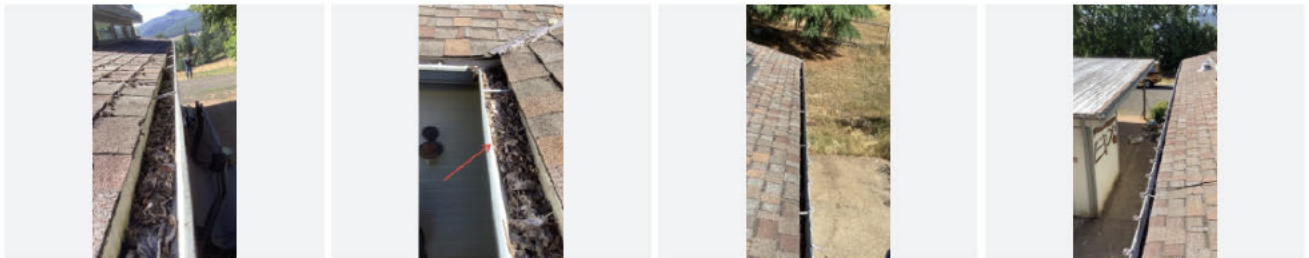
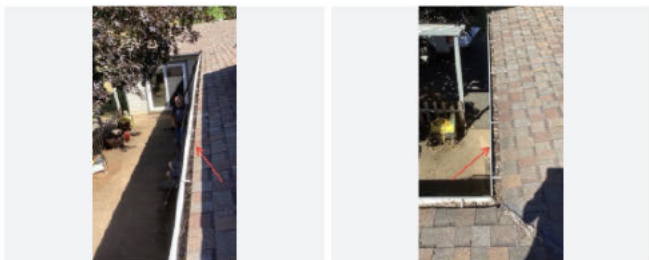
Marginal

Gutters are filled with debris, recommend cleaning by a Gutter Cleaning Service or DIY, to restore proper water flow.

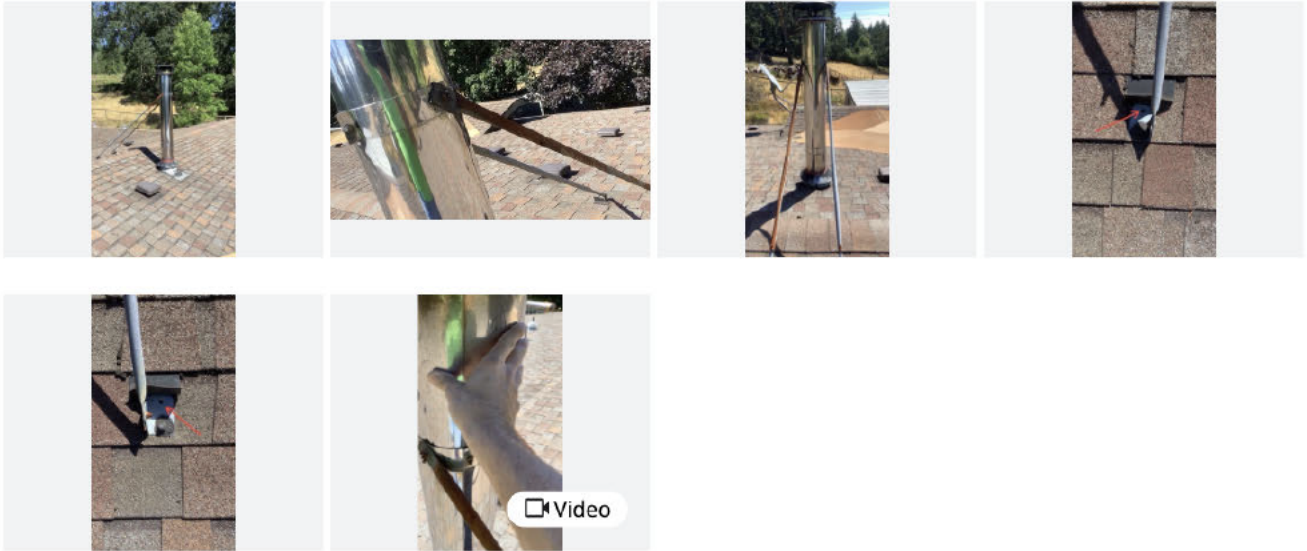
Defective

The chimney supports are rusted and loose, recommend replacement.

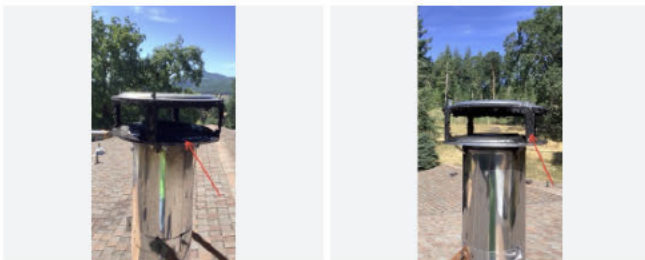
Heavy creasote buildup observed, recommend a Chimney Sweep Service before use.

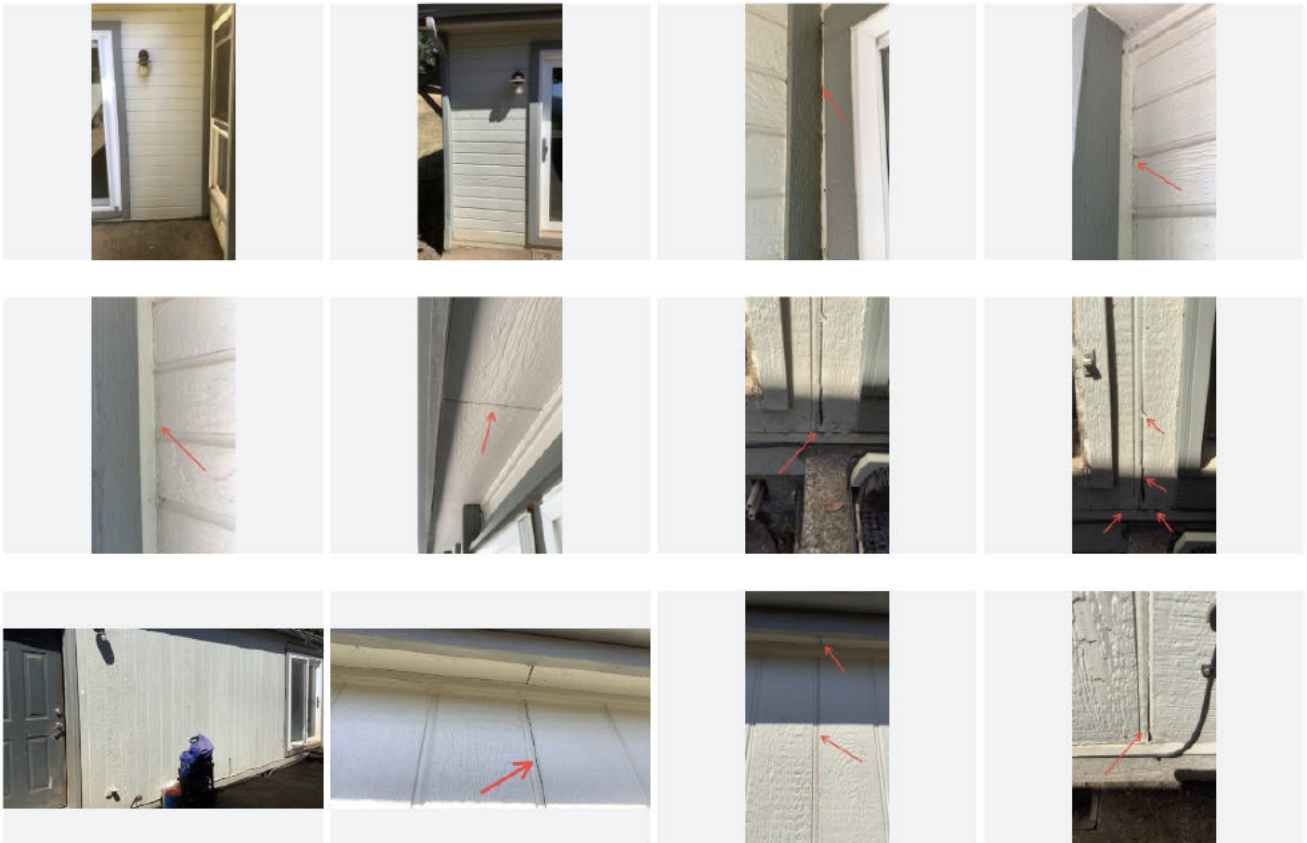
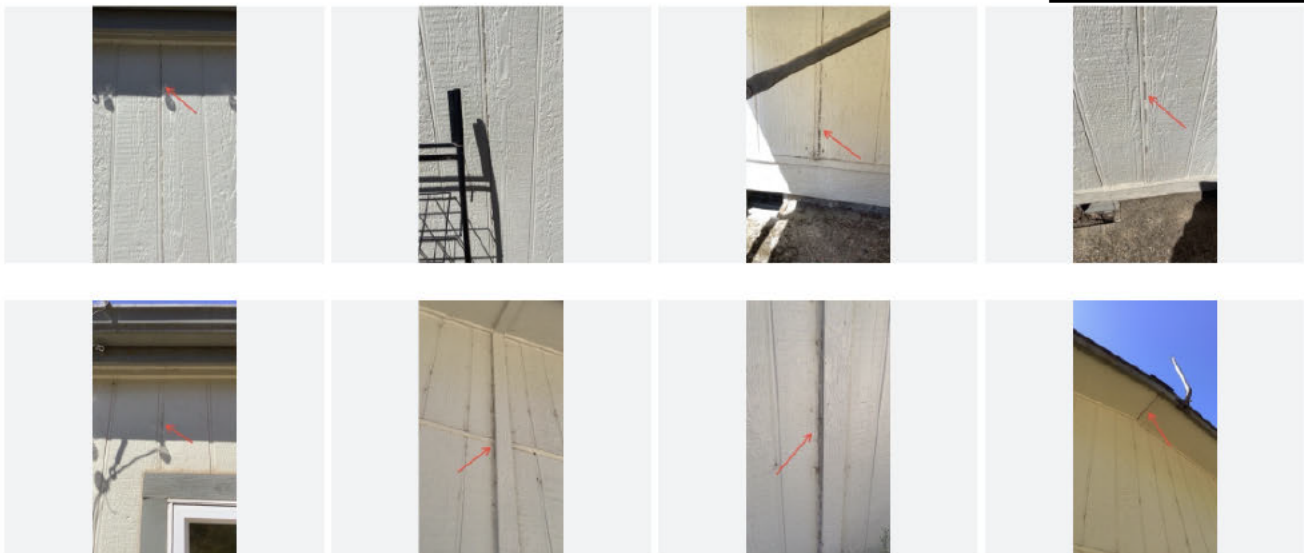
Marginal

The majority of the siding was in good condition, however there were areas of wood rot near the bottom and several areas where cracks and seams were observed. Recommend sealing all cracks and seams to prevent moisture intrusion either by a Handyman service or DIY project.

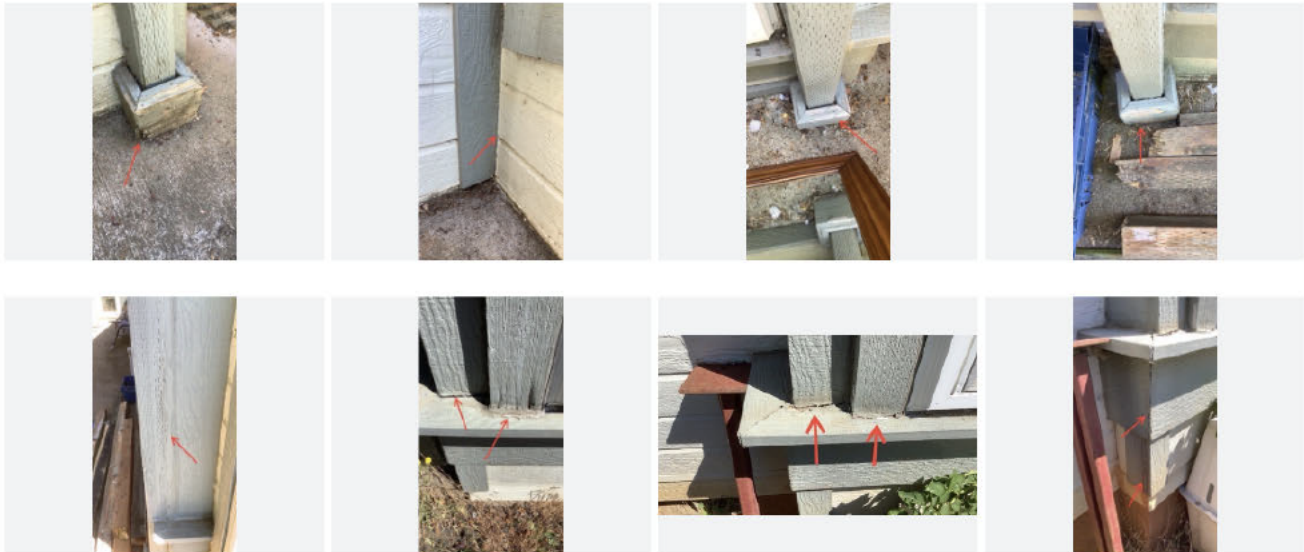
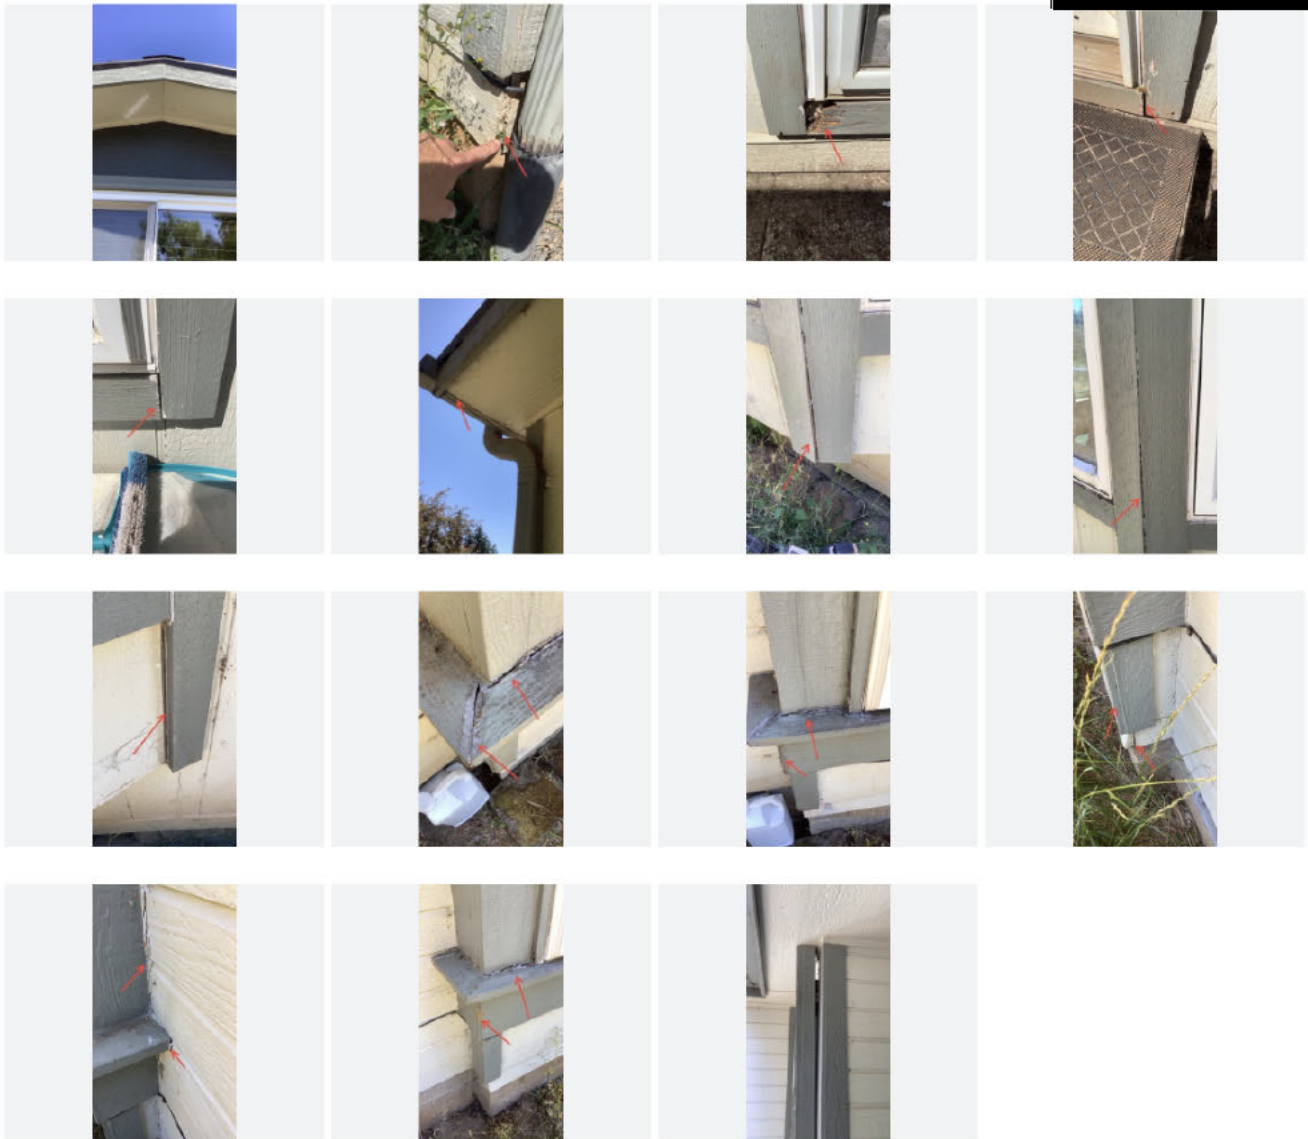
Marginal

Several areas of the trim showed evidence of wood rot and/or weather damage, and open seams, gaps or cracks, recommend replacing all areas of wood rot and sealing/caluking the gaps and seams.

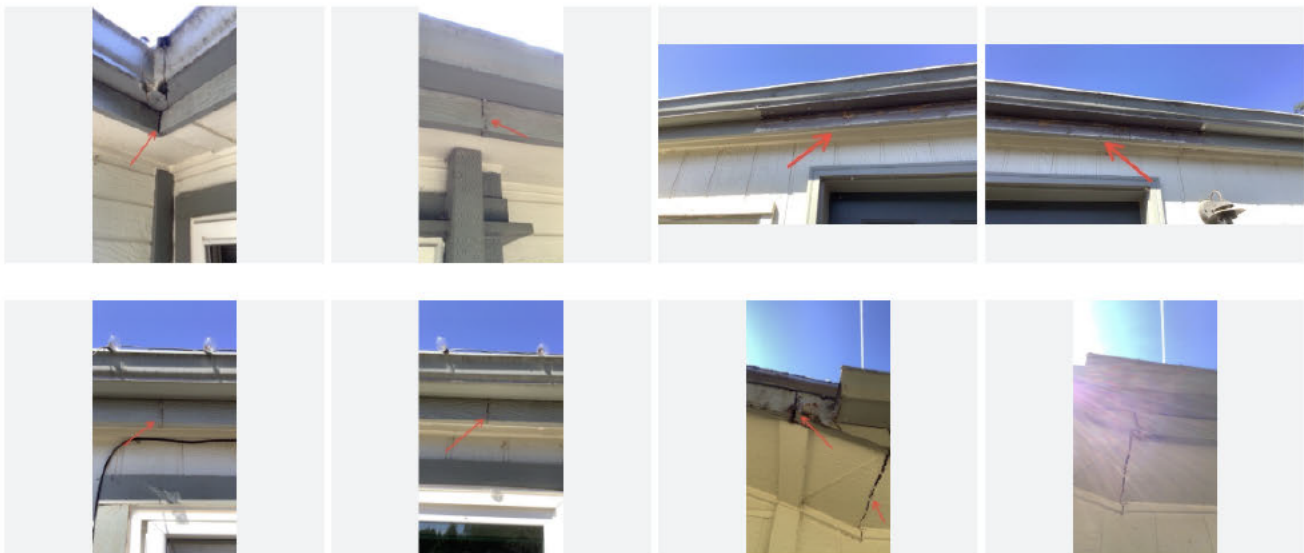
Marginal

Several areas of the fascia had open seams or gaps, recommend sealing/caulking.

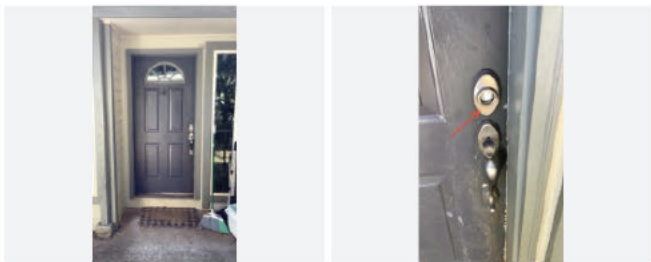
Marginal

Loose or missing hardware, recommend replacement.

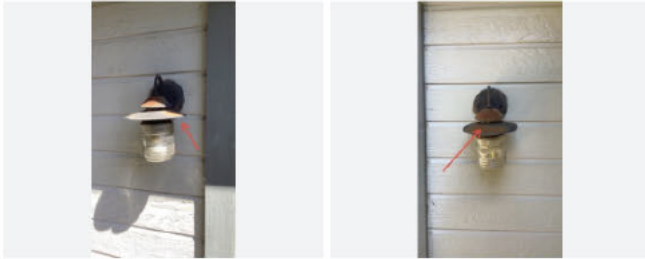
Marginal

Replace rusted or weathered light fixtures as needed.

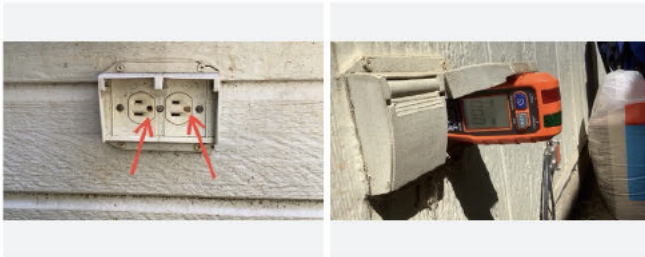
Defective

Non-GFCI outlets observed and in the first photo the grounds were plugged so the outlet could not be tested, recommend correction by a licensed Electrician and install GFCI outlets on exterior.

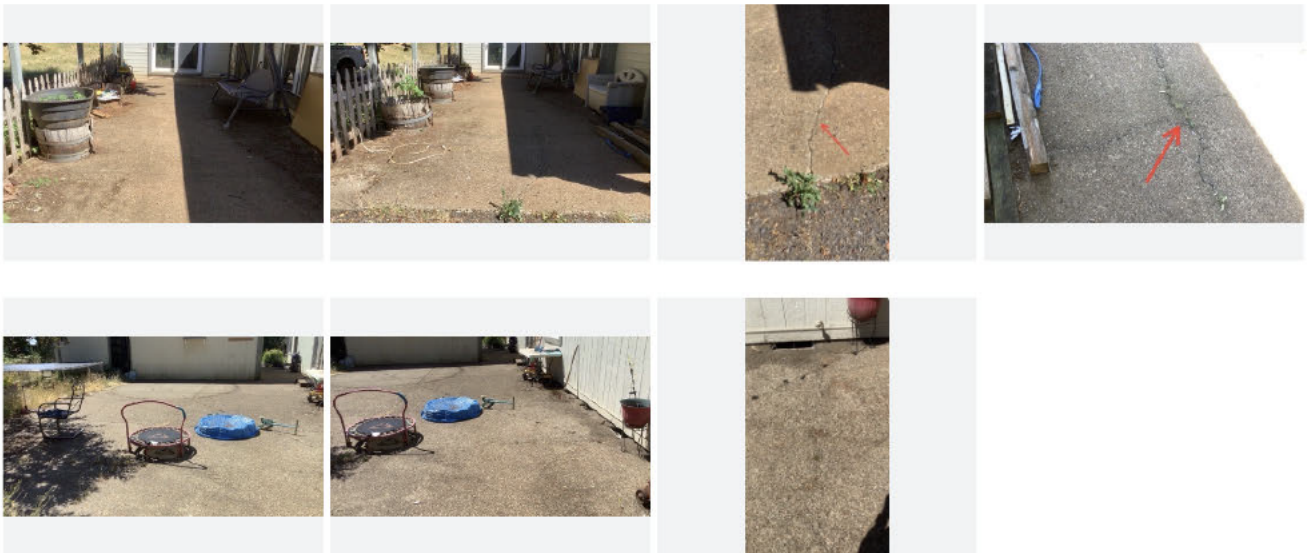
Marginal

Cracks were observed on the patio surface, recommend power washing the cracks to remove dirt and debris then filling with a concrete epoxy to help prevent further cracking.

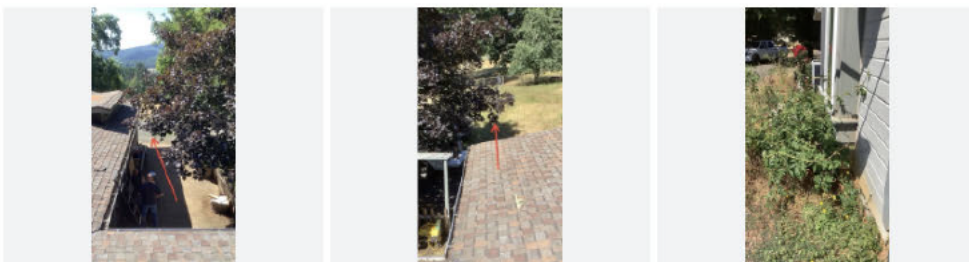
Marginal

Tree limbs over hang the roof and should be cut back and some shrubs were too close to the siding, recommend trimming back a minimum of 12 inches.

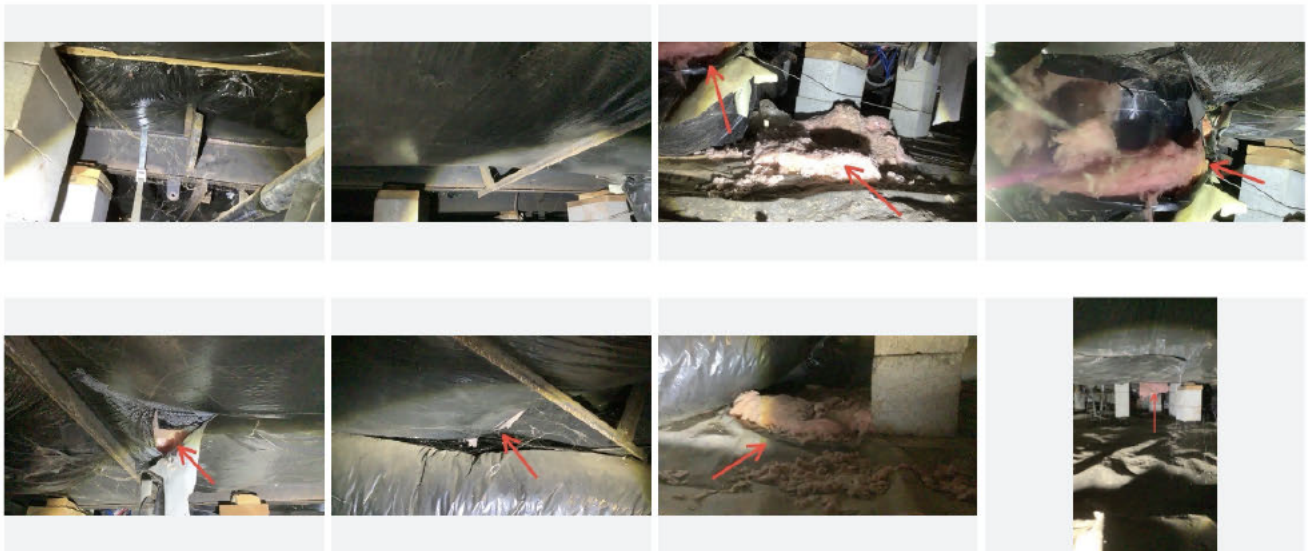
Marginal

Some of the insulation was torn or missing in areas, recommend a Handyman Service for correction of these areas.

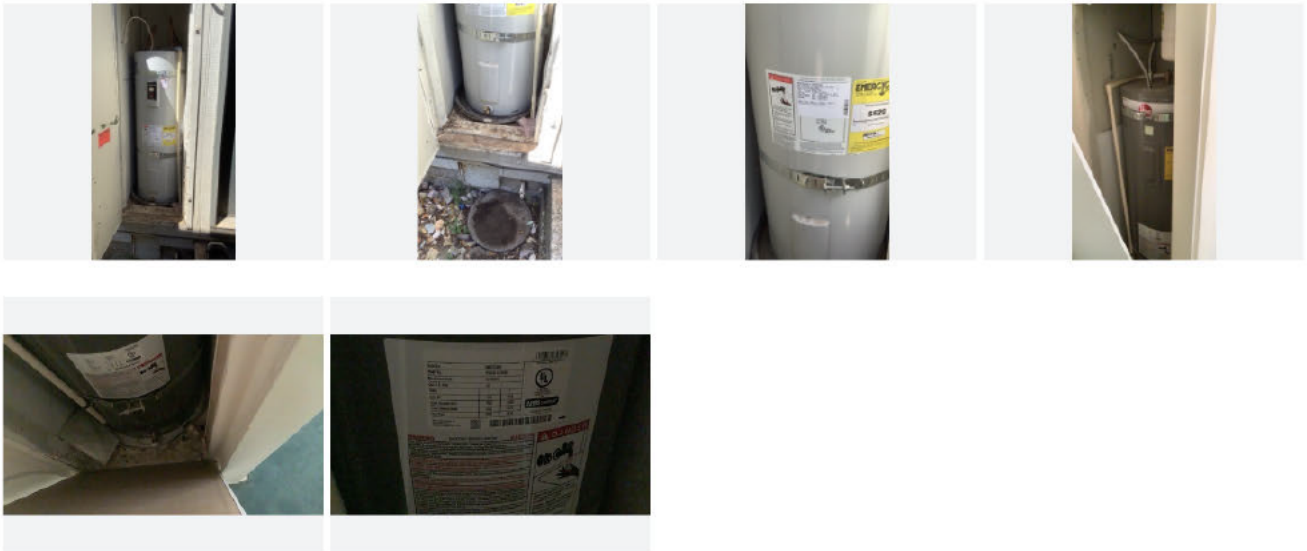
There were two water heaters in this home. The first 3 photos were on the exterior near the rear patio and the other 3 were in the bedroom inside.

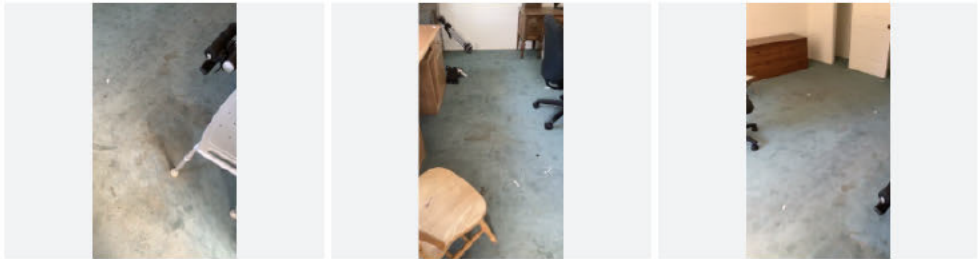
Marginal

Carpet Stained/soiled

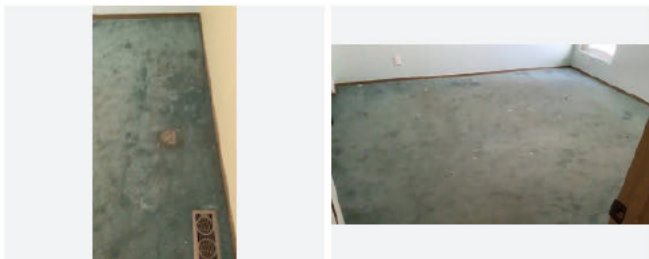
Marginal

Carpet Stained/soiled

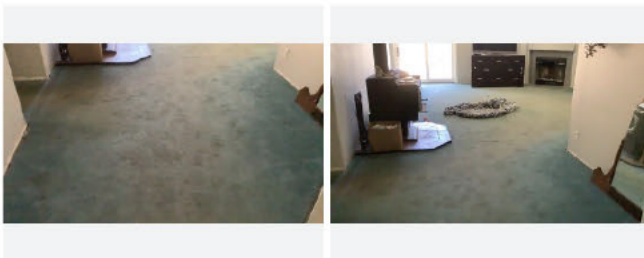
Carpet Stained/soiled

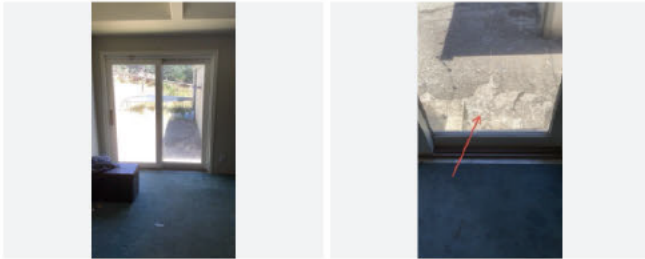
Torn screen, recommend replacment.

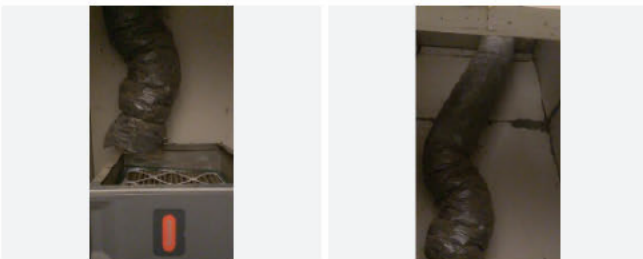
Loose

Duct work is improperly installed, recommend an HVAC Tech for service and correction.
